RCRA Compliance Evaluation Inspection

Yuasa Battery, Inc.
2901 Montrose Ave.
Laureldale, PA 19605

Dates of Inspection: September 15 & 22, 2009

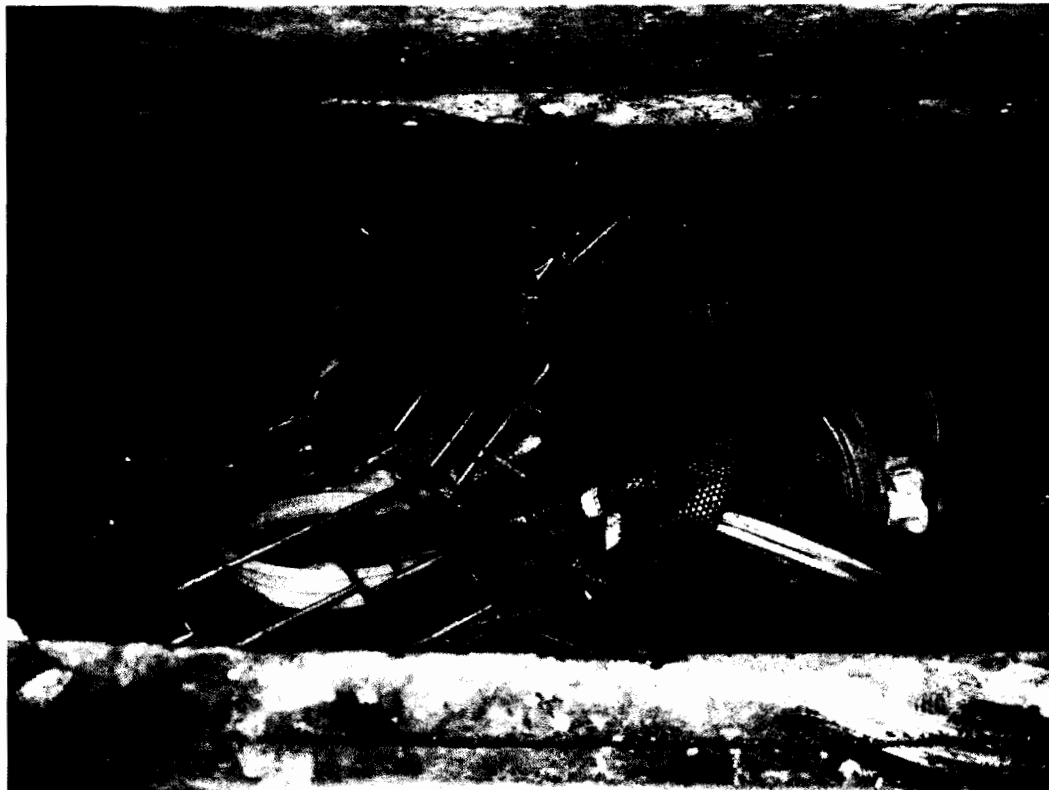
An additional hopper was found in the Formation area, labeled as HW and dated 10/13/08 (Photos 36 & 37). It appeared to be full of various lead-contaminated materials (Photo 38).

Photo 36: HW hopper in Formation area, labeled HW and dated 10/13/08

Photo 37: Close-up of label on Photo 36 hopper

Photo 38: View inside Photo 36 hopper

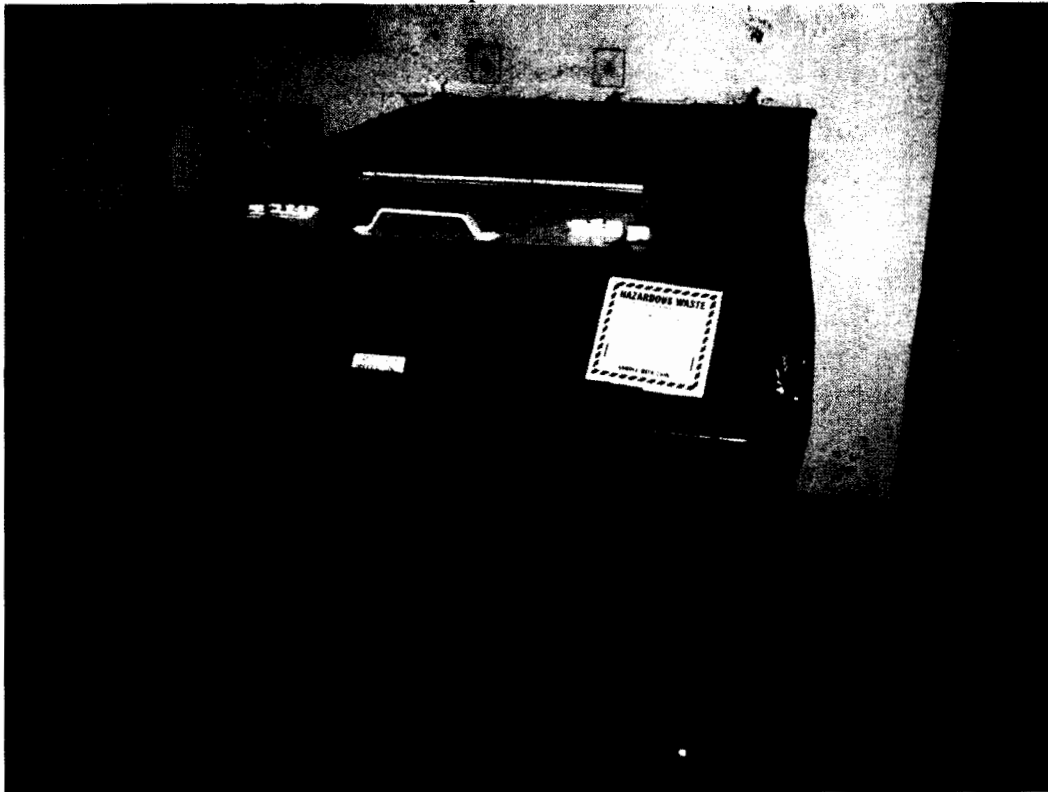
Another hopper was found in the Maintenance/Case Formation/Distribution Center area (referred to by the representatives as the "community" hopper), labeled as containing HW, full, and undated (Photos 39 - 41). The HW label referred to the contents as being "RQ, UN3077, Hazardous waste, solid, N.O.S., 9, PG III (Lead)" -- similar to what is listed on the facility's stickers for material going out for reclamation, but including the phrase "Hazardous waste."

Photo 39: HW hopper in Maintenance/Case Formation/Distrib. Center

Photo 40: View inside Photo 39 hopper

Photo 41: Close-up of label on Photo 39 hopper -- no date

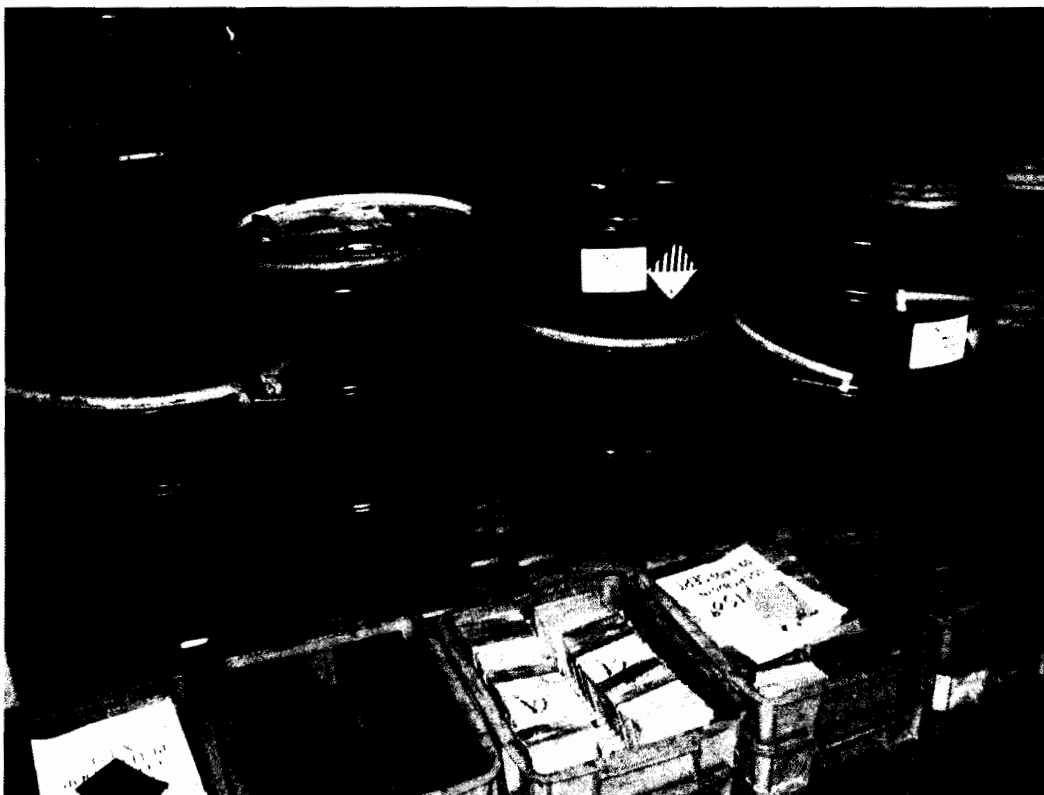
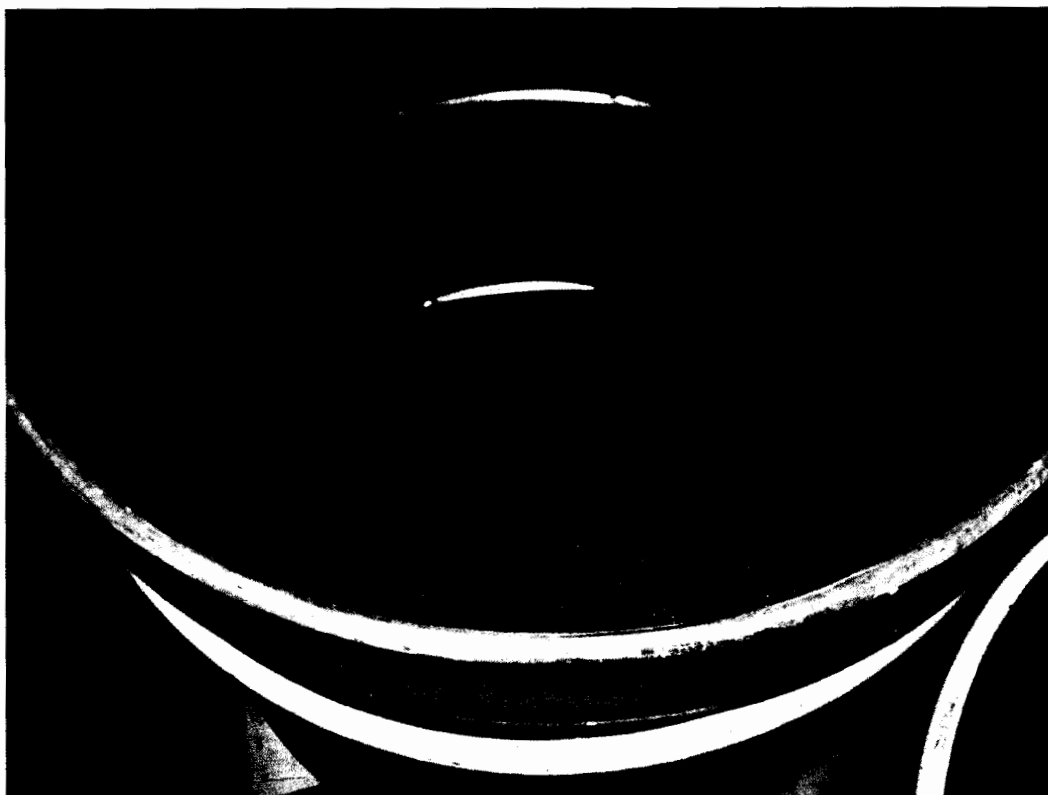
In the Plate Parting area, four 55gal drums were found (Photo 42). The black drum photographed on the far left was open and about 1/3 full of various solids (Photo 43). The blue

Photo 42: Four 55gal drums found in Plate Parting area

Photo 43: View inside leftmost drum from Photo 42

Photo 44: View inside rightmost drum from Photo 42

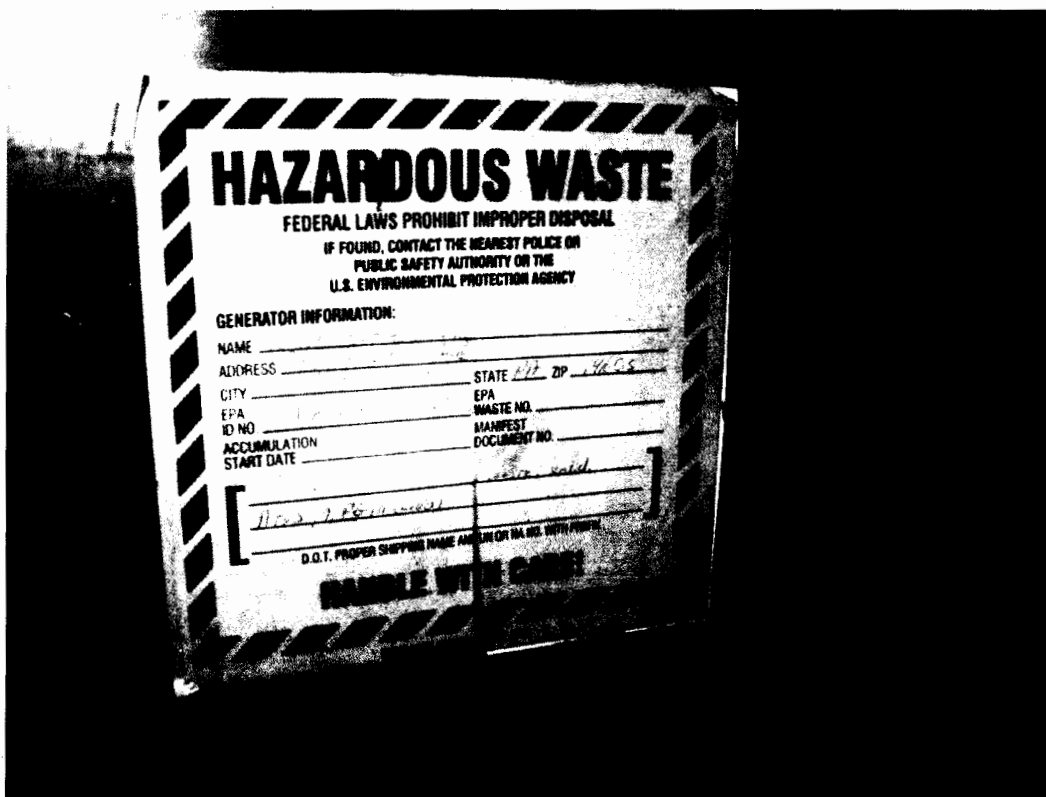
In the Assembly area another hopper was found labeled as HW, undated, and full of what was described as “separator material” by the representatives (Photos 45 - 47).

Photo 45: HW hopper in Assembly area

Photo 46: Close-up of label from Photo 45 hopper -- no date

Photo 47: View inside Photo 45 hopper

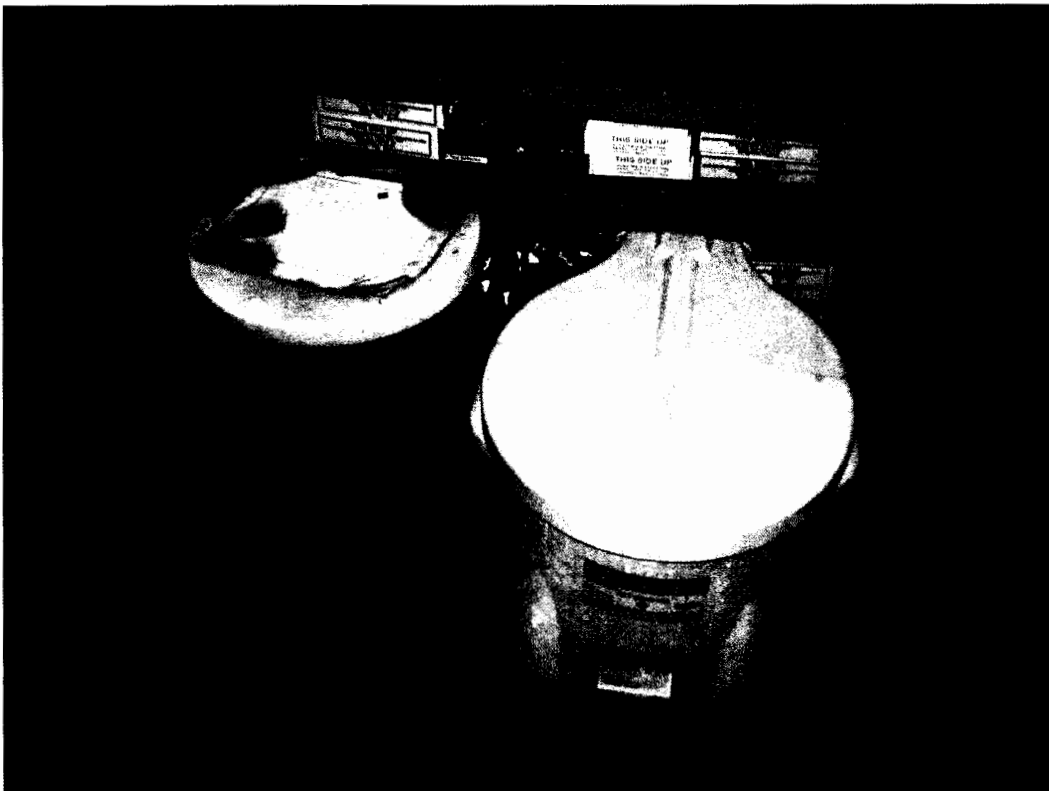
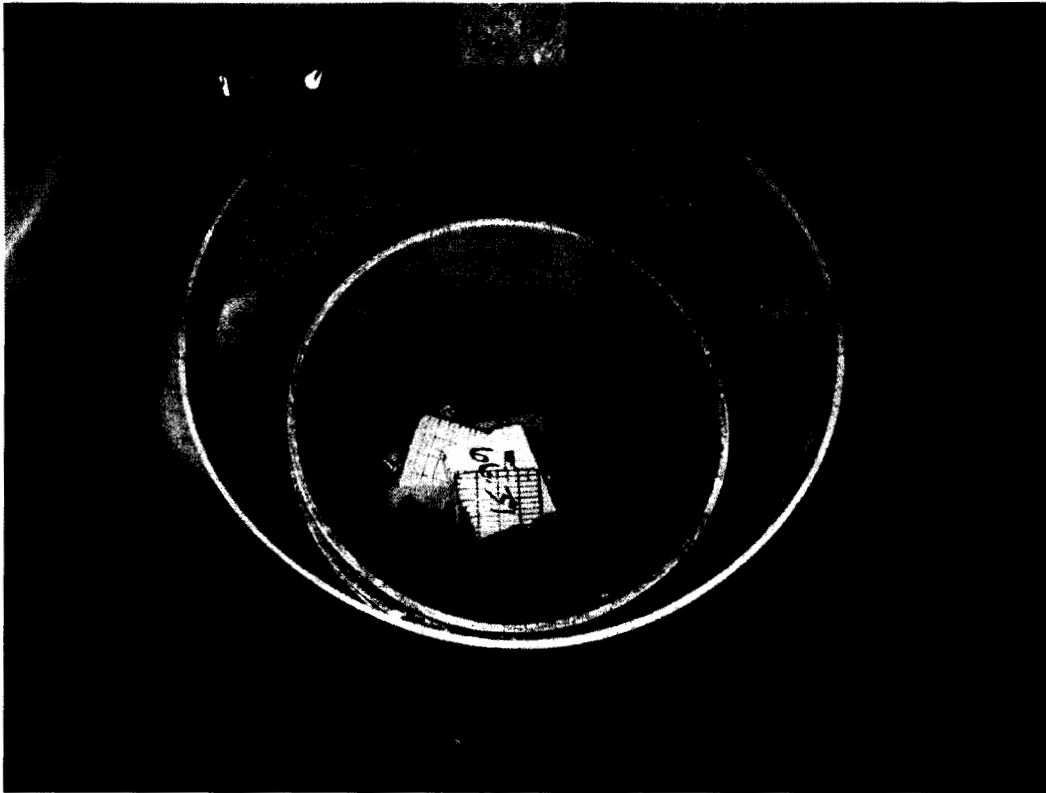
Two plastic containers were found here in an area intended as satellite collection (Photo 48). The blue container shown on the left was labeled as “Hazardous waste satellite storage barrel” whereas the yellow container was unlabeled. It contained a smaller plastic container inside it which itself held a small amount of solids (Photo 49), and was described by Mr. Richards as intended to go out for recycling at the smelter.

Photo 48: Two containers in QC Lab

Photo 49: Contents of unlabeled container on right from Photo 48

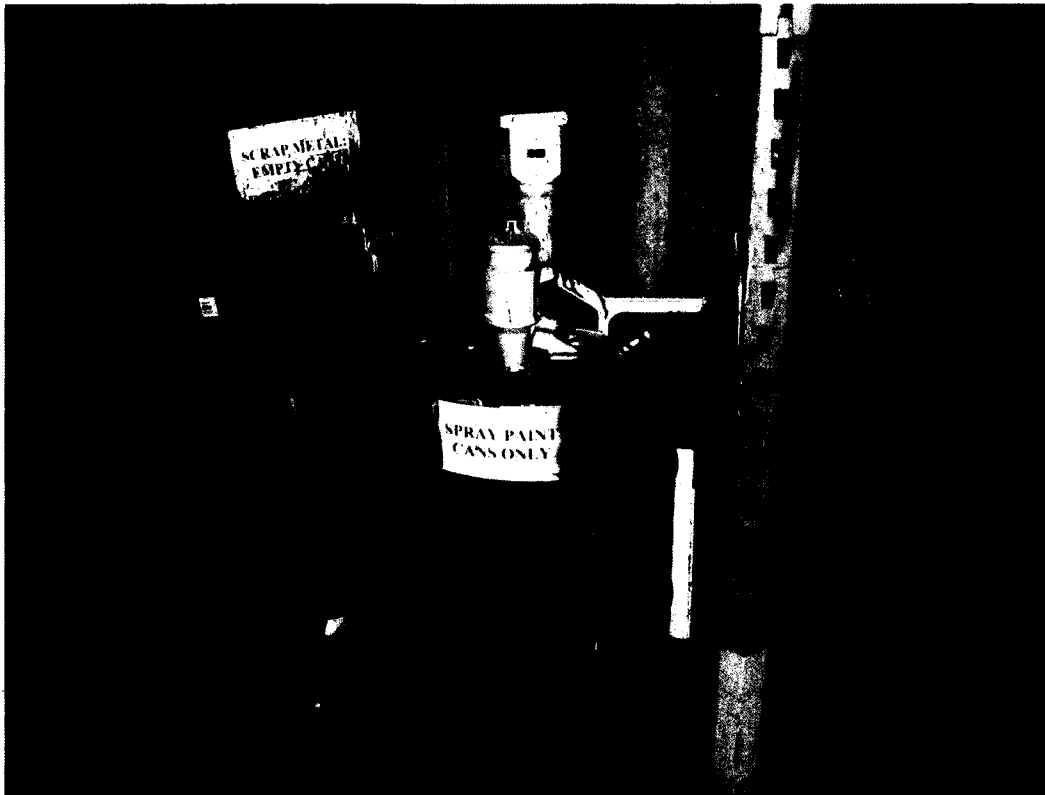
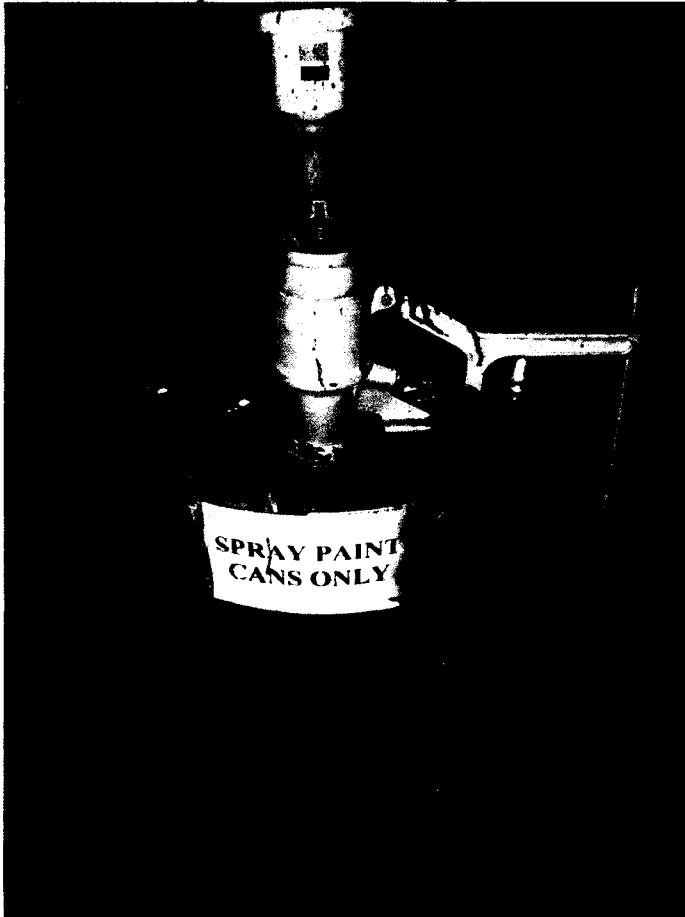
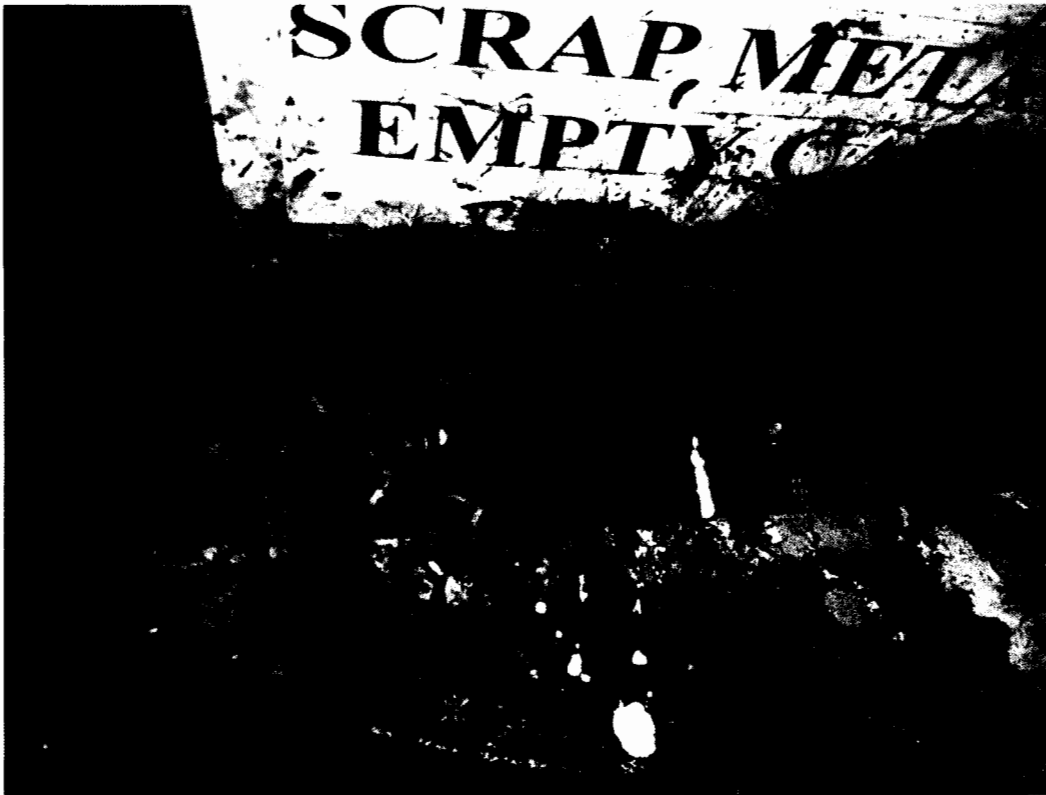
Photo 50: Can puncturer and storage drum in Grid Storage/HW Room

Photo 51: Close-up of can puncturing drum

Photo 52: View inside can storage drum from Photo 50

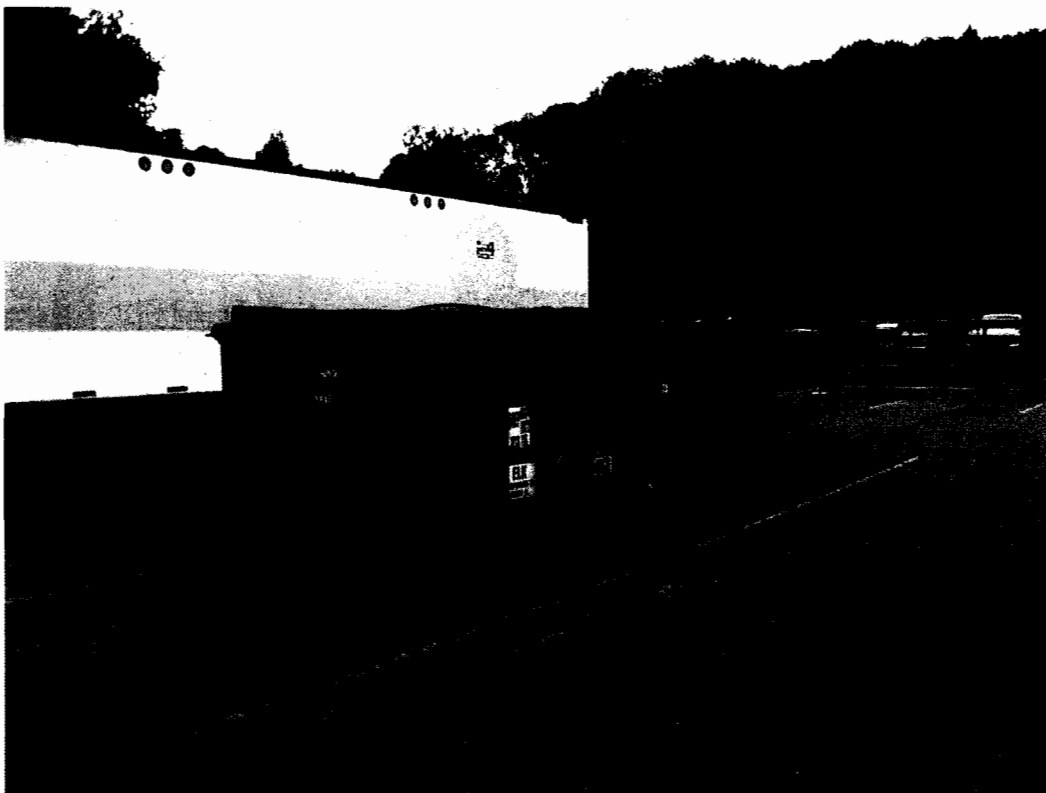
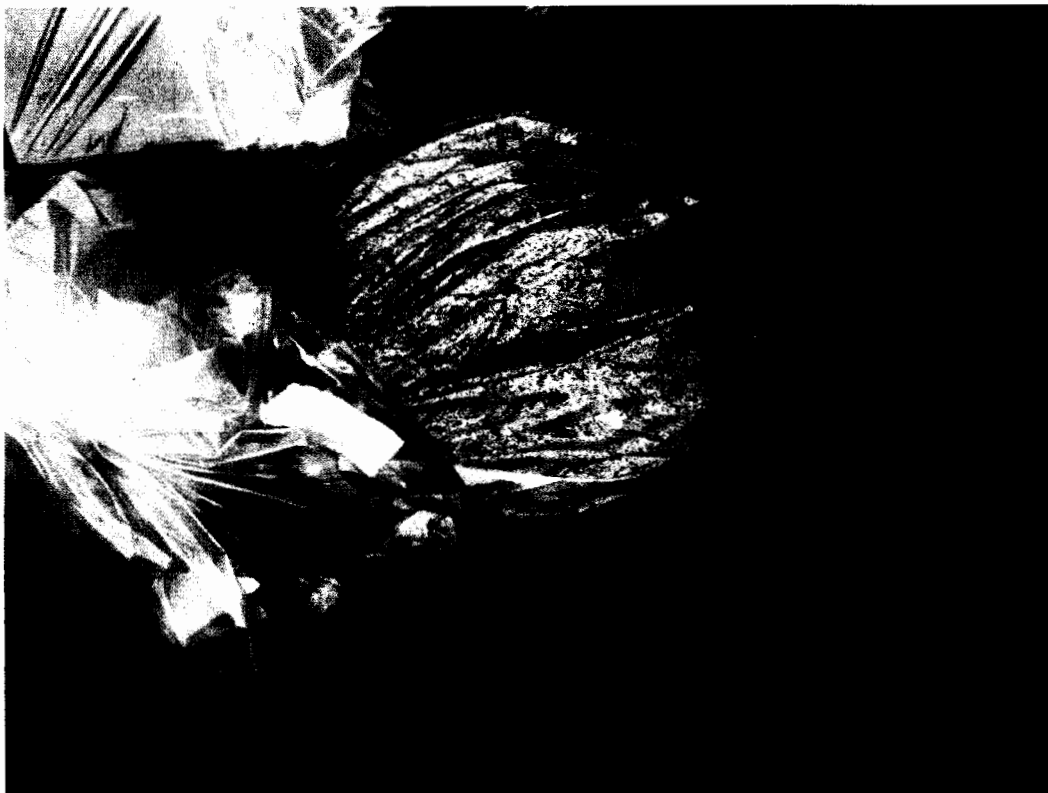
Photo 53: Open HW roll-off container in storage area

Photo 54: Label on Photo 53 roll-off container (also labeled as "Residual Waste")

Photo 55: View into roll-off container from above -- individual bags appeared closed but unlabeled

Photo 56: Additional view into roll-off from above

Photo 57: Additional view of roll-off contents
